Superfund 3rd Five-Year Review Report Smith's Farm Landfill Brooks, Bullitt County, Kentucky

Smith's Farm Landfill
5-Year Review Final Report
September 2006

Third Five-Year Review Report

**Smith's Farm Landfill
Brooks, Bullitt County, Kentucky
September 2006**

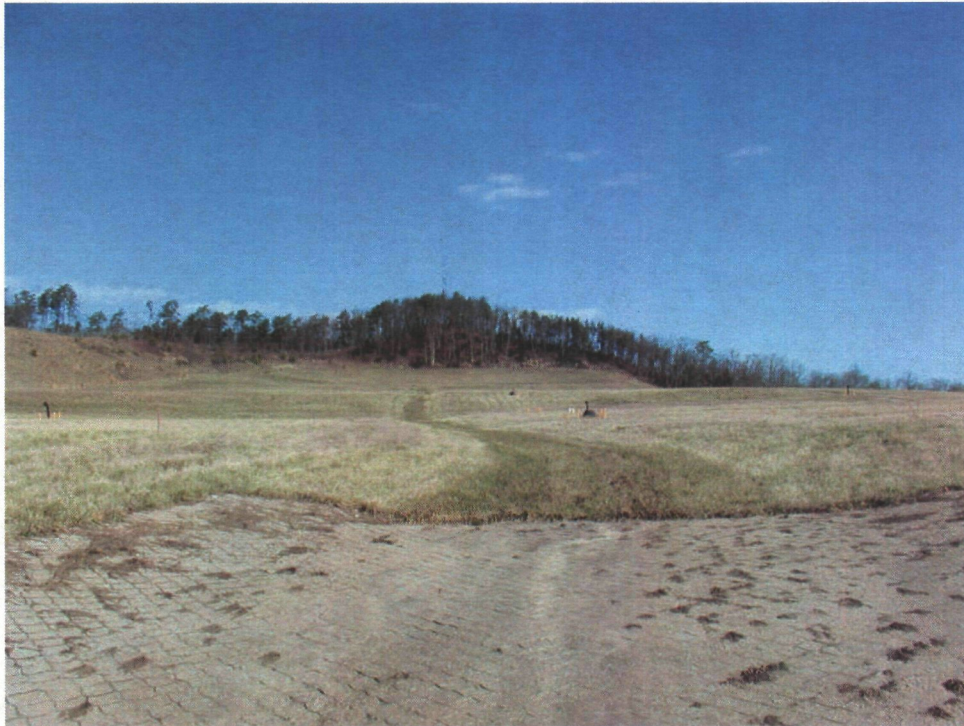
Photo 13- View to north across top of OU2: Improved vegetation is evident

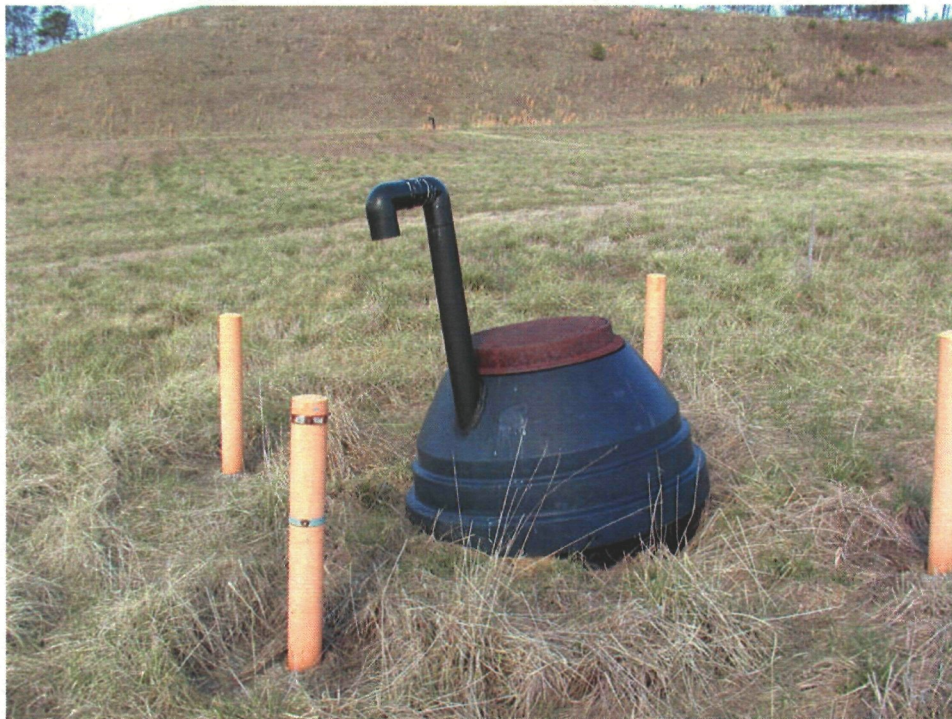
Photo 14- OU2 Typical Extraction Well, and Gas Vent: Some erosion and rodent burrowing evident at base

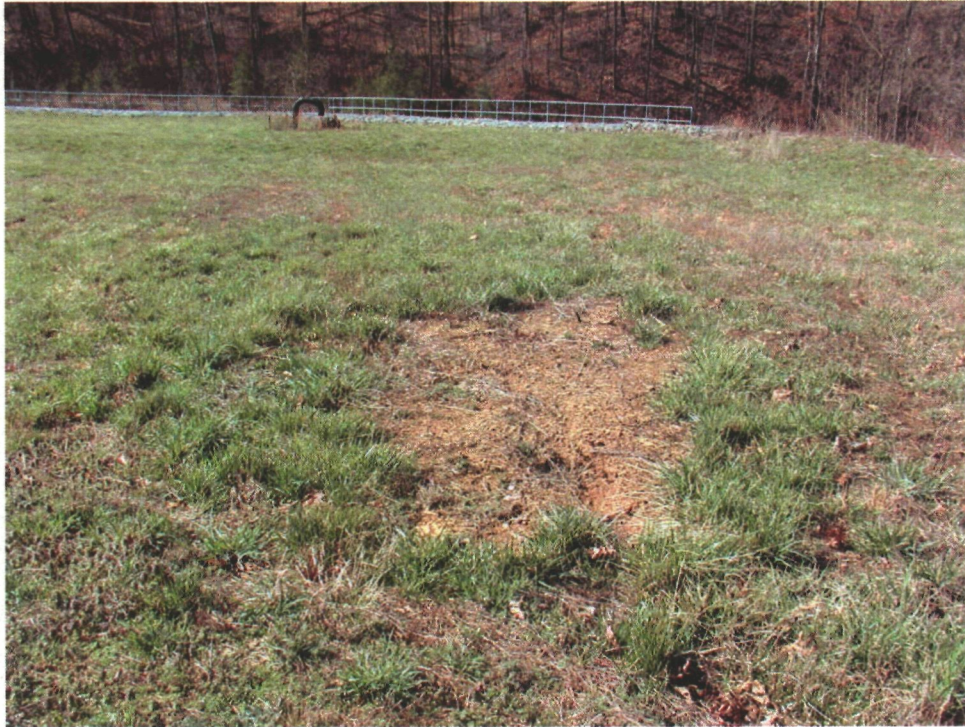
Photo 25- Small Area of Stressed Vegetation at OU1

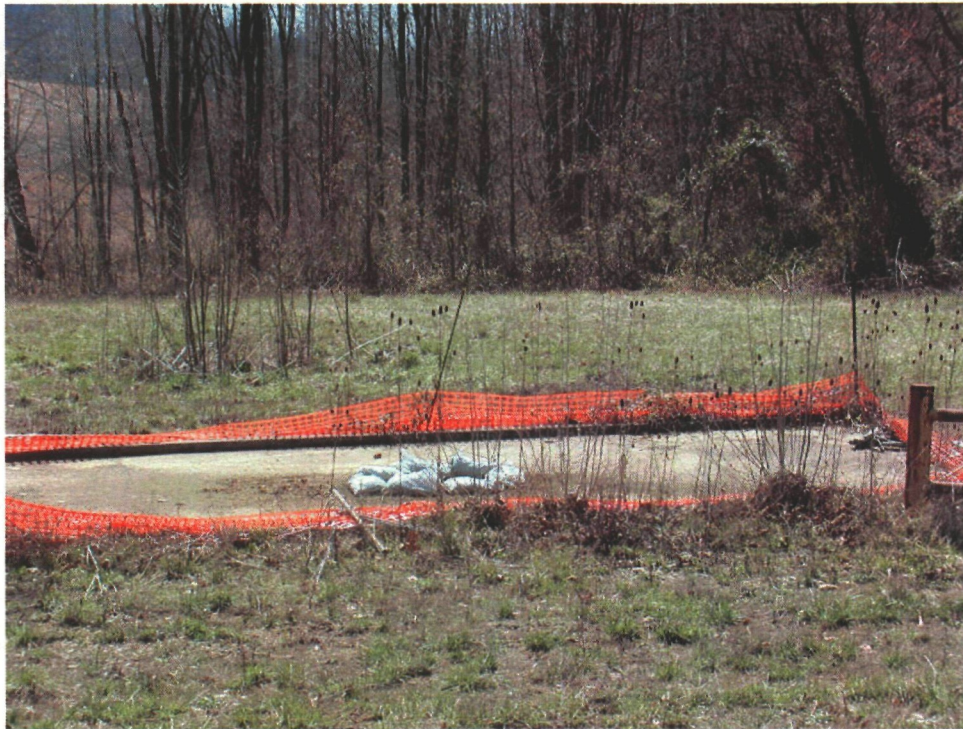
Photo 27- Sandbags protecting drain from debris at southernmost corner of OU1.

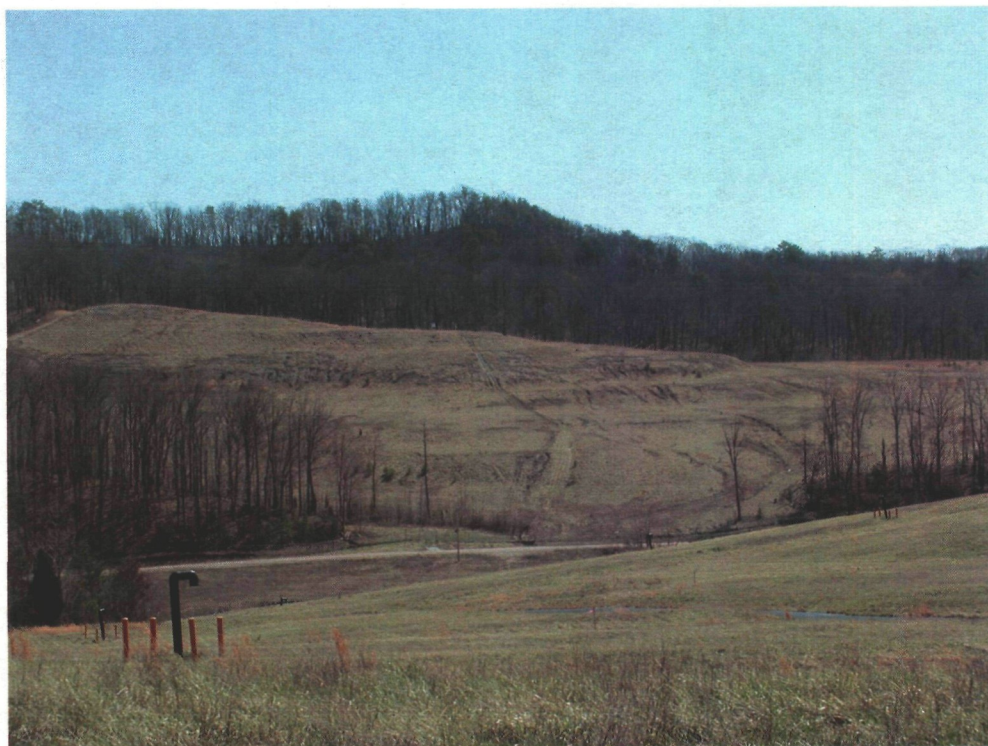
Photo 38- Bike Trails on Smith Farm Property, Trespassing.

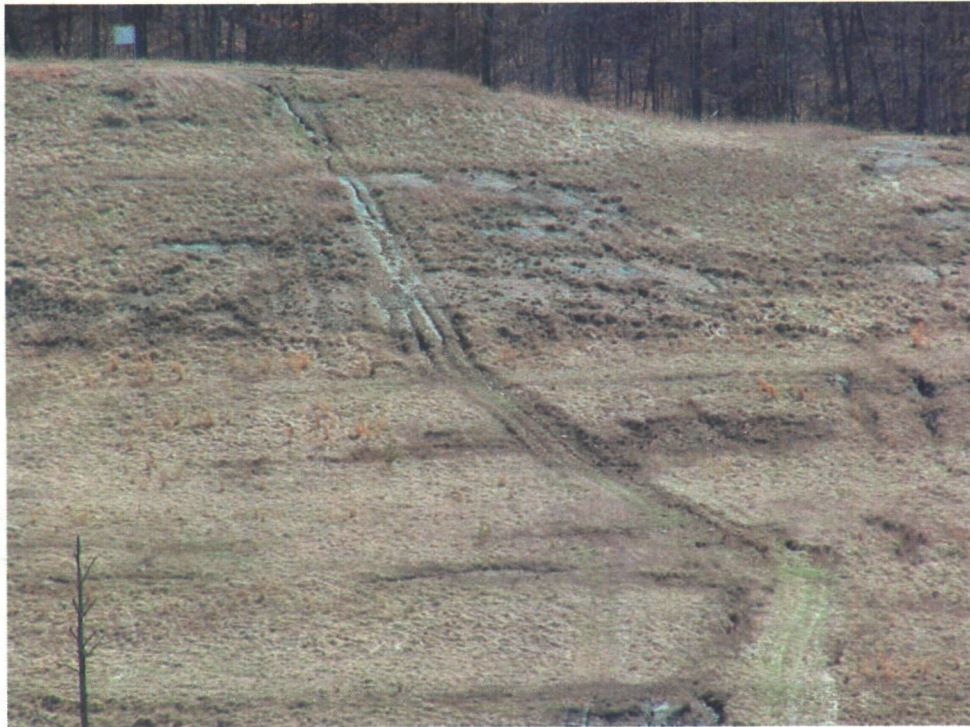
Photo 39- Bike Trails on Smith Farm Property, Trespassing.

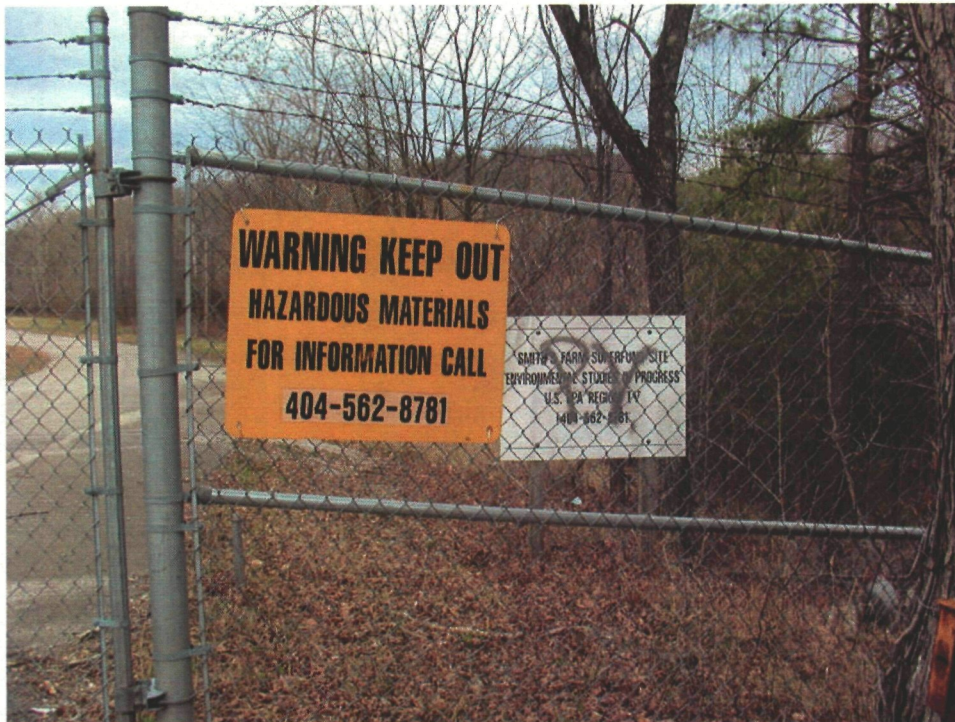
Photo 40- Sign Vandalism

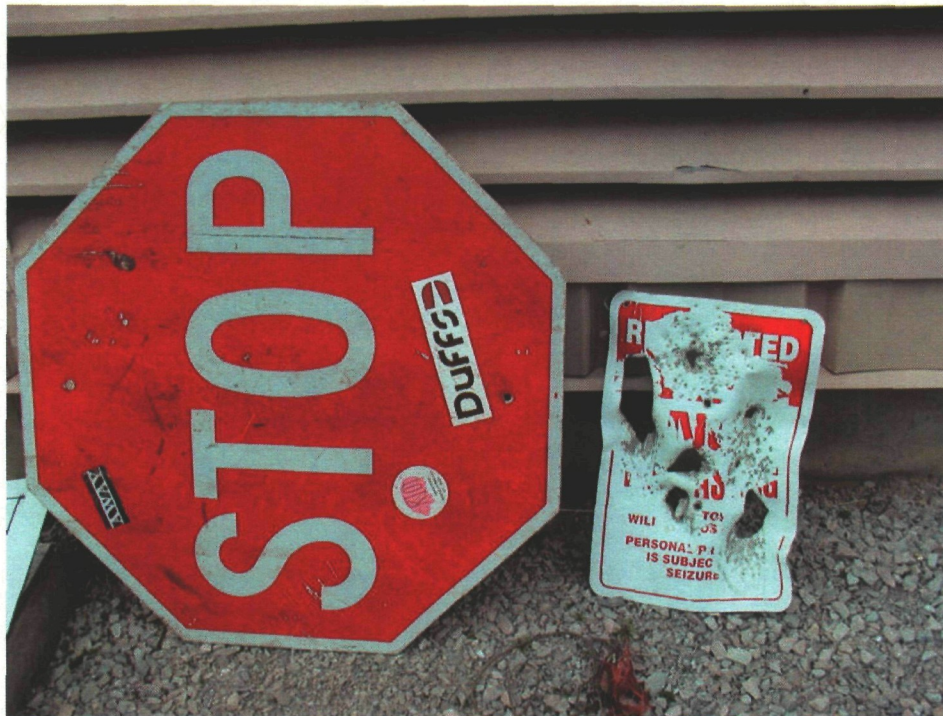
Photo 41- Sign Vandalism

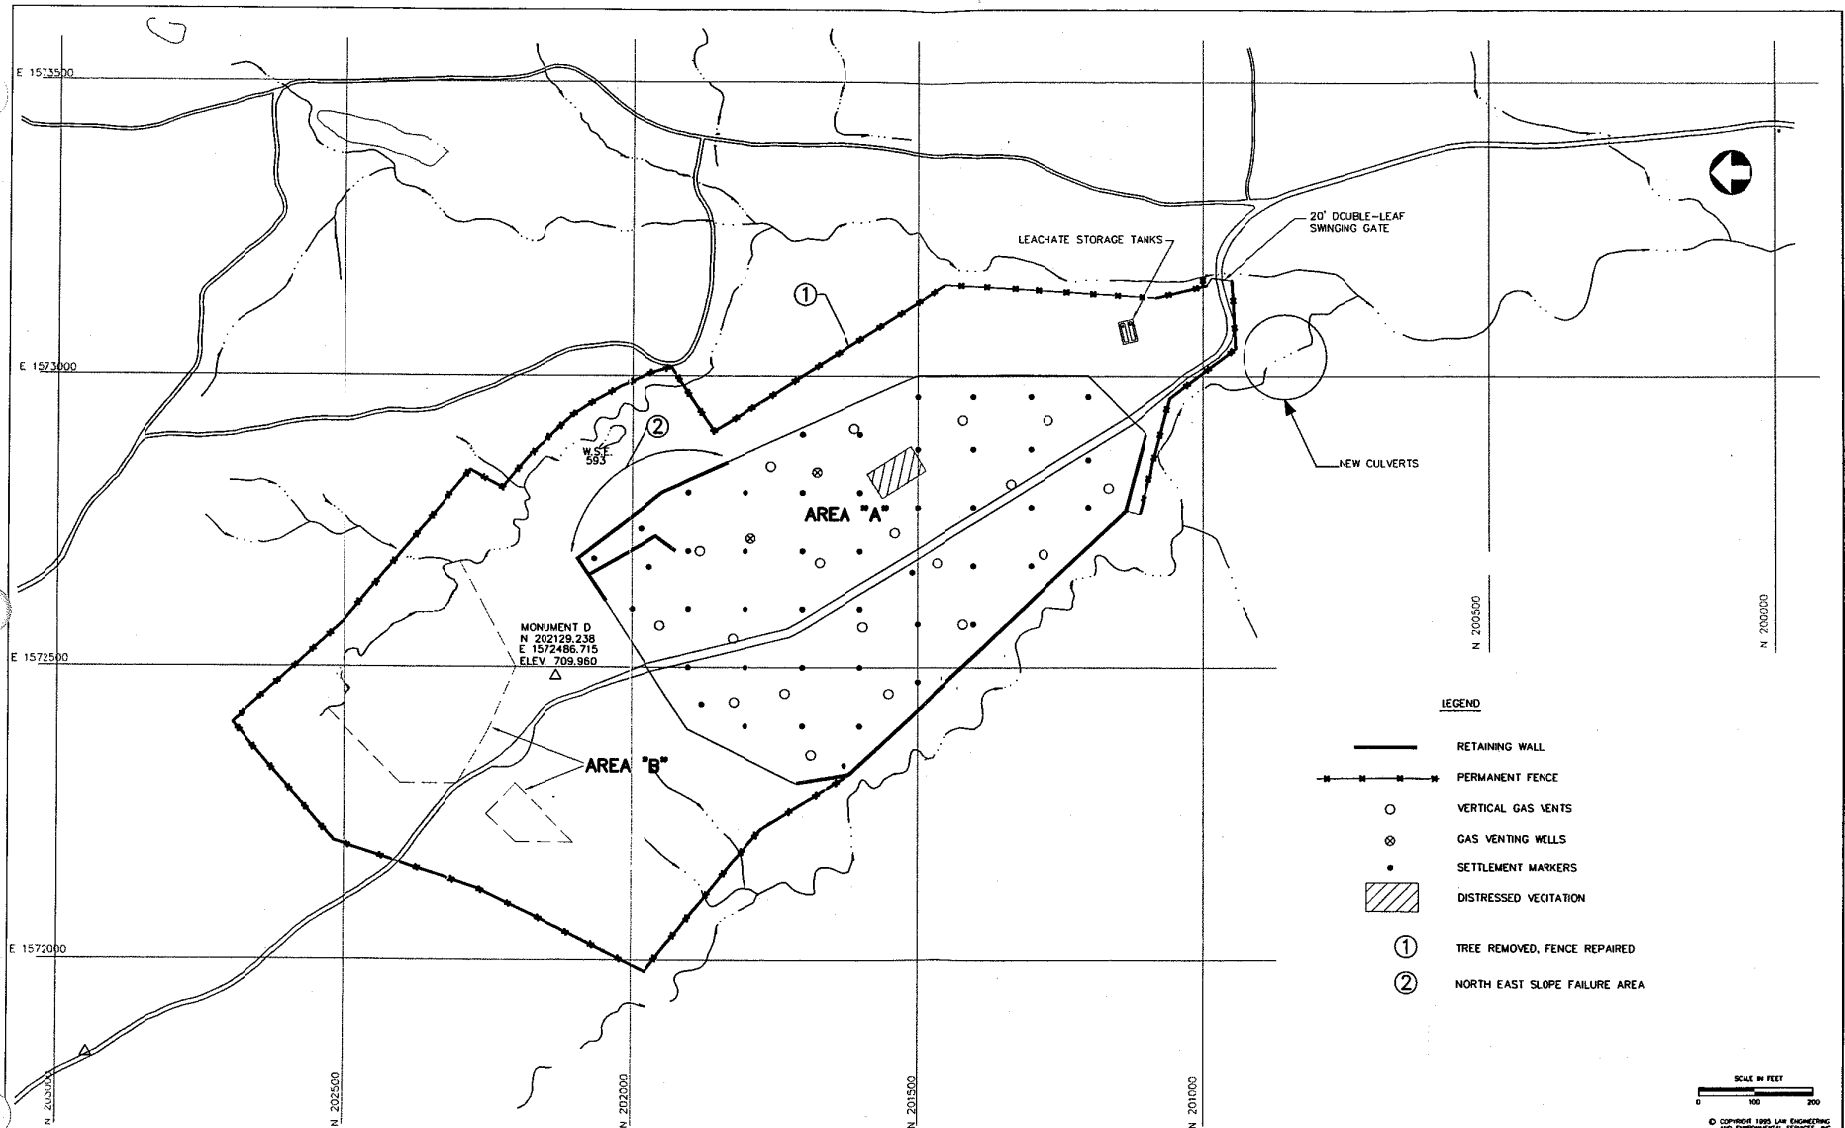
- RETAINING WALL
- PERMANENT FENCE
- VERTICAL GAS VENTS
- GAS VENTING WELLS
- SETTLEMENT MARKERS
- DISTRESSED VEGETATION
- ① TREE REMOVED, FENCE REPAIRED
- ② NORTH EAST SLOPE FAILURE AREA

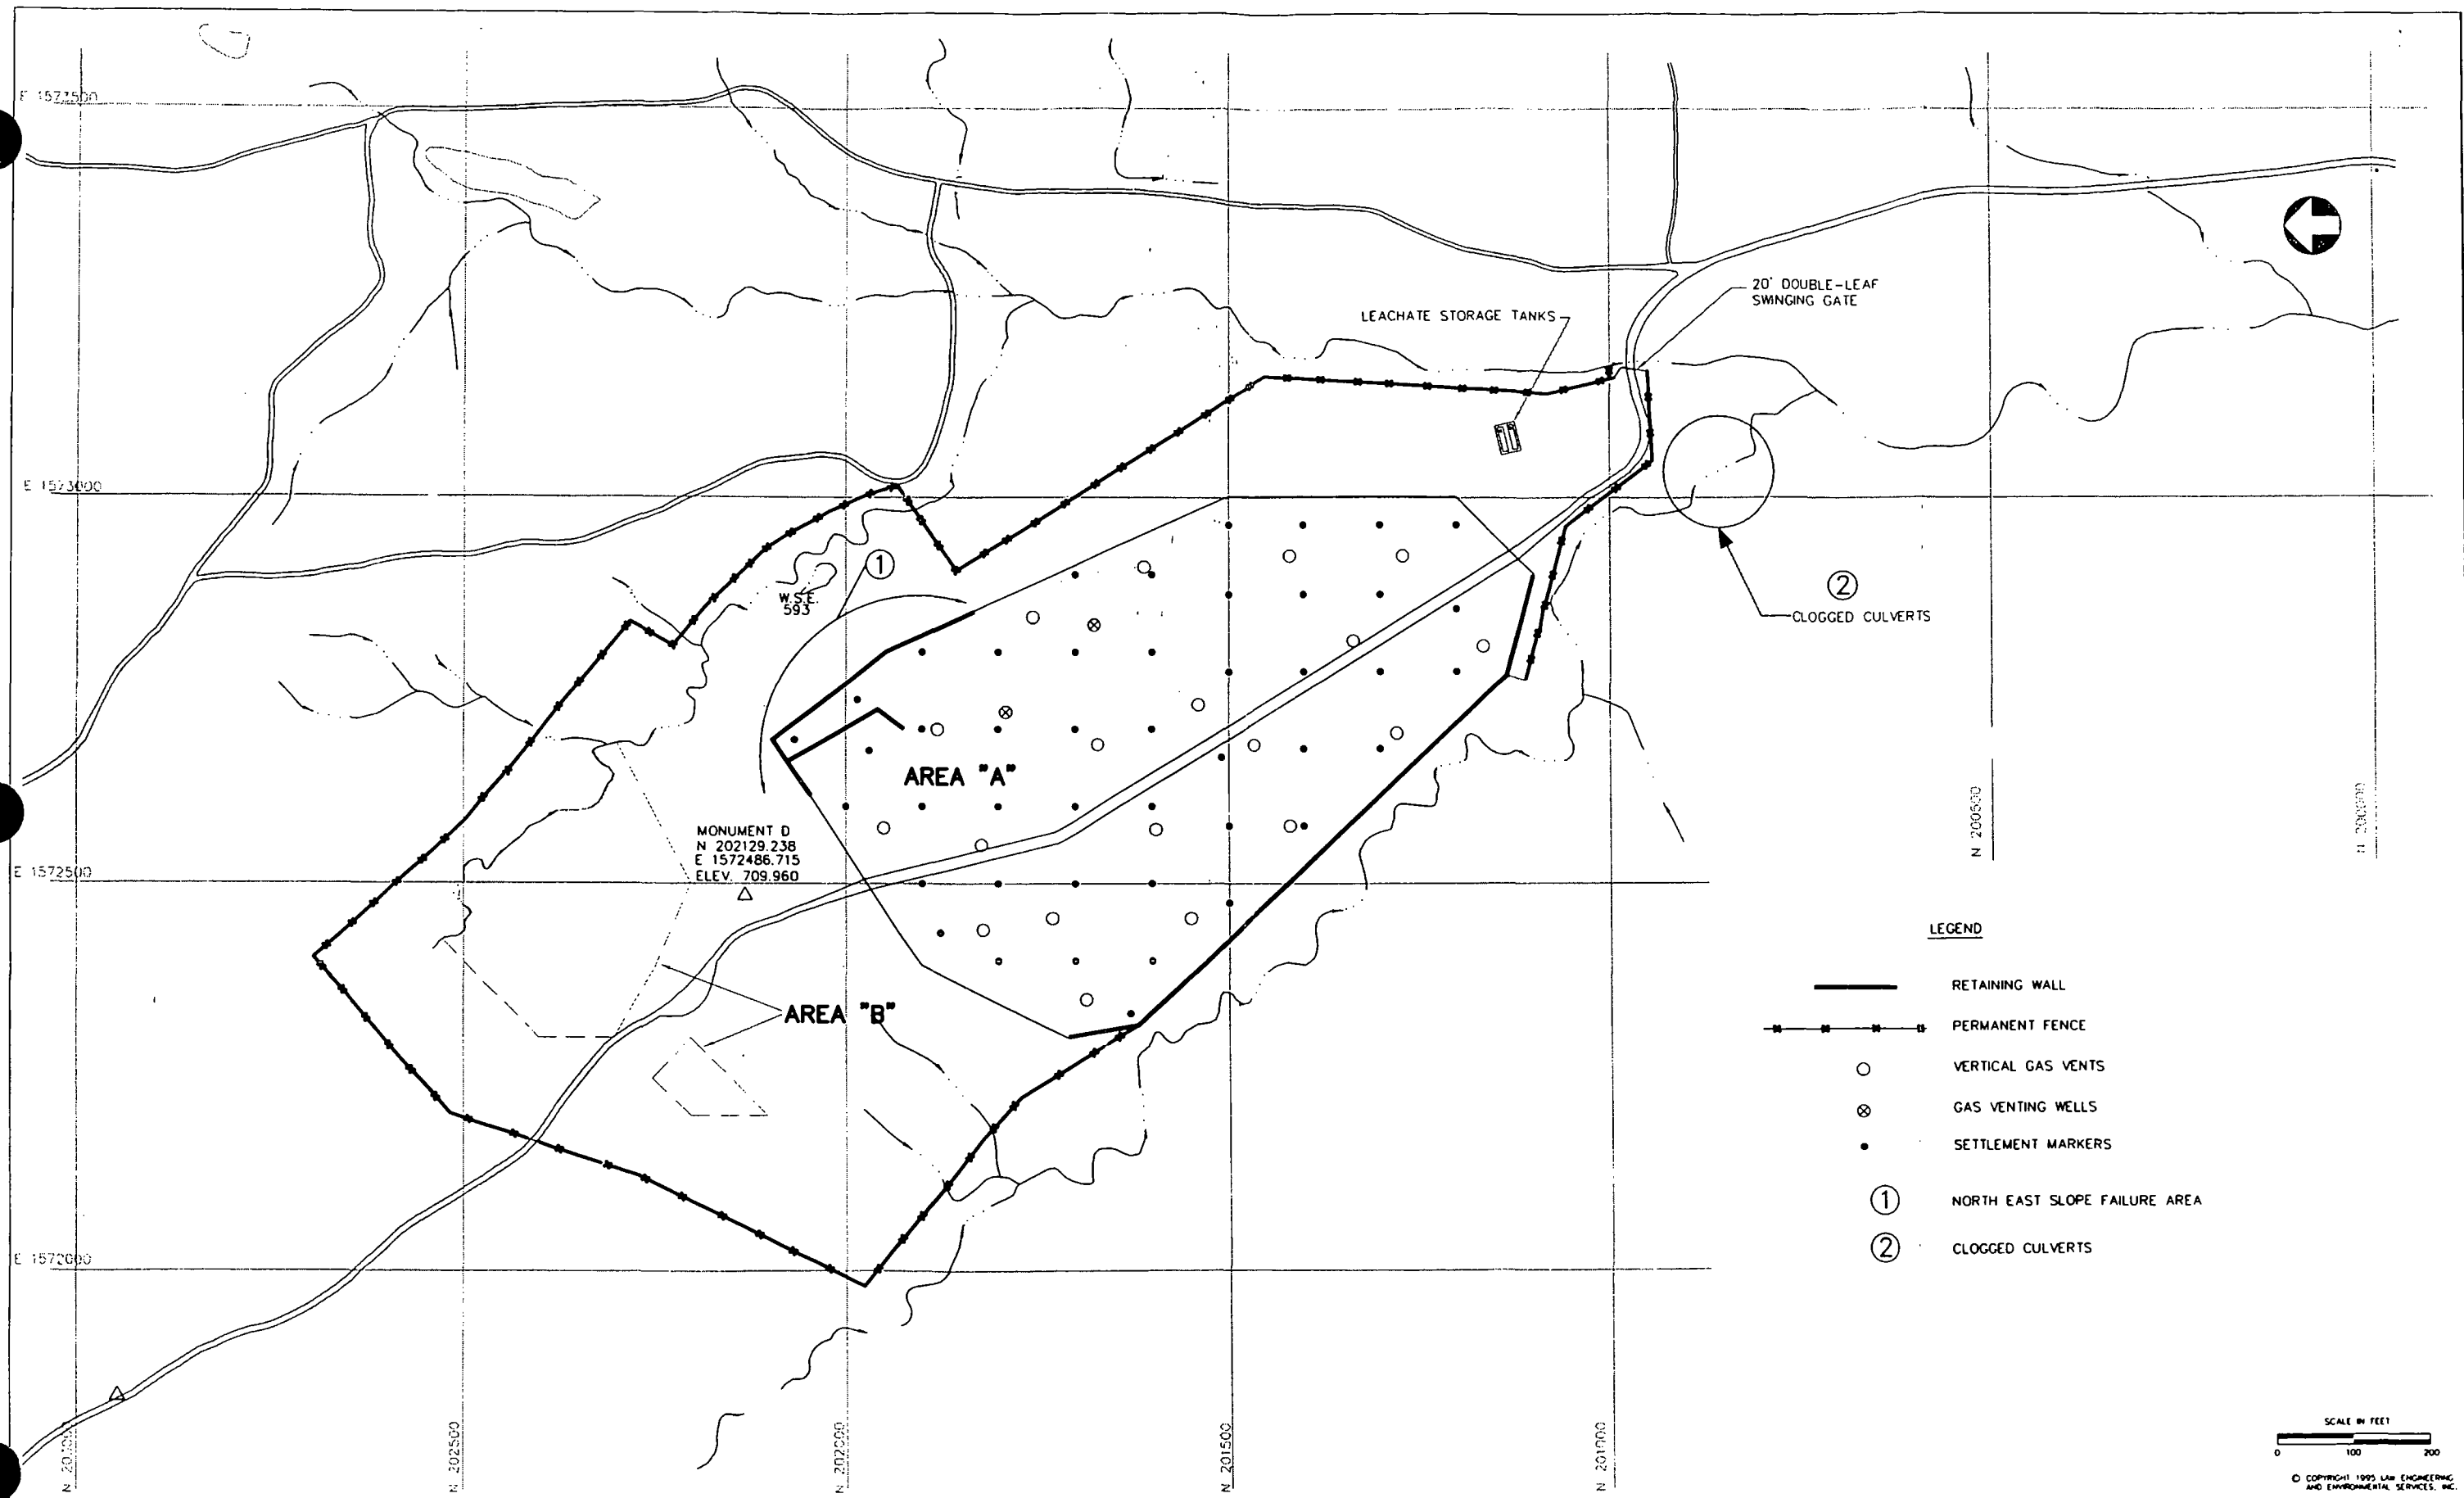
- RETAINING WALL
- +—+—+— PERMANENT FENCE
- VERTICAL GAS VENTS
- ⊗ GAS VENTING WELLS
- SETTLEMENT MARKERS
- ① NORTH EAST SLOPE FAILURE AREA
- ② CLOGGED CULVERTS

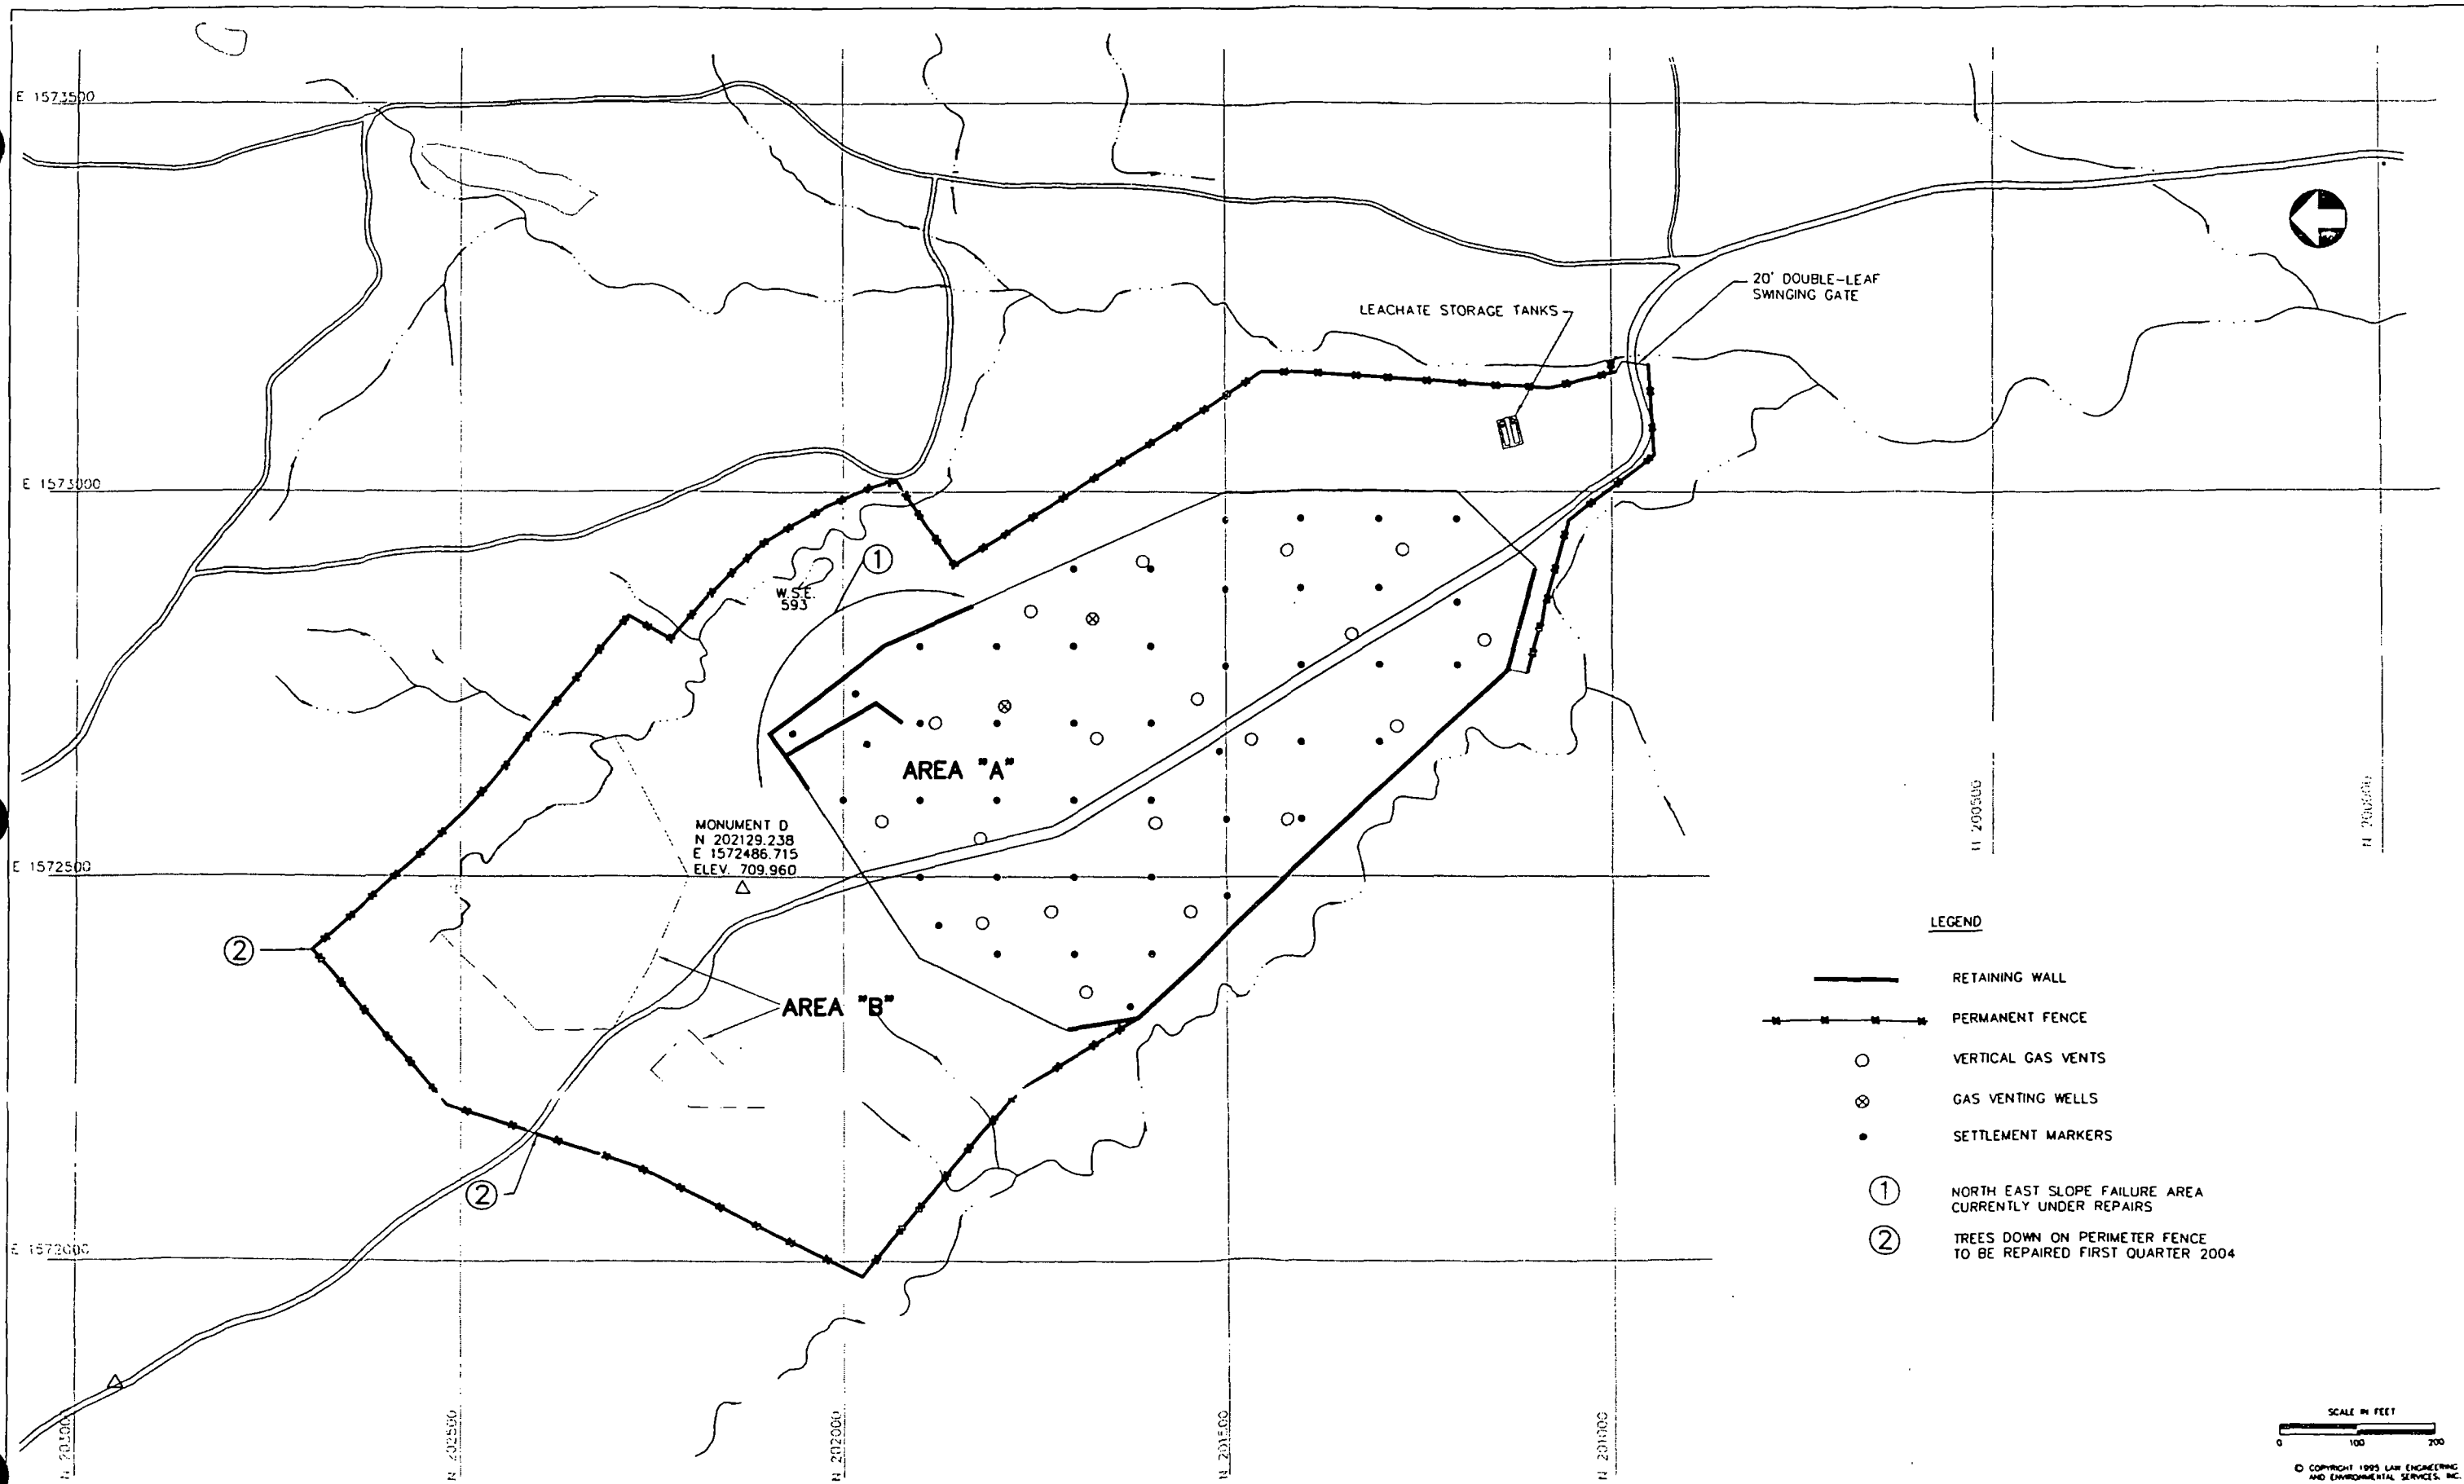
- RETAINING WALL
- PERMANENT FENCE
- VERTICAL GAS VENTS
- GAS VENTING WELLS
- SETTLEMENT MARKERS
- ① NORTH EAST SLOPE FAILURE AREA CURRENTLY UNDER REPAIRS
- ② TREES DOWN ON PERIMETER FENCE TO BE REPAIRED FIRST QUARTER 2004

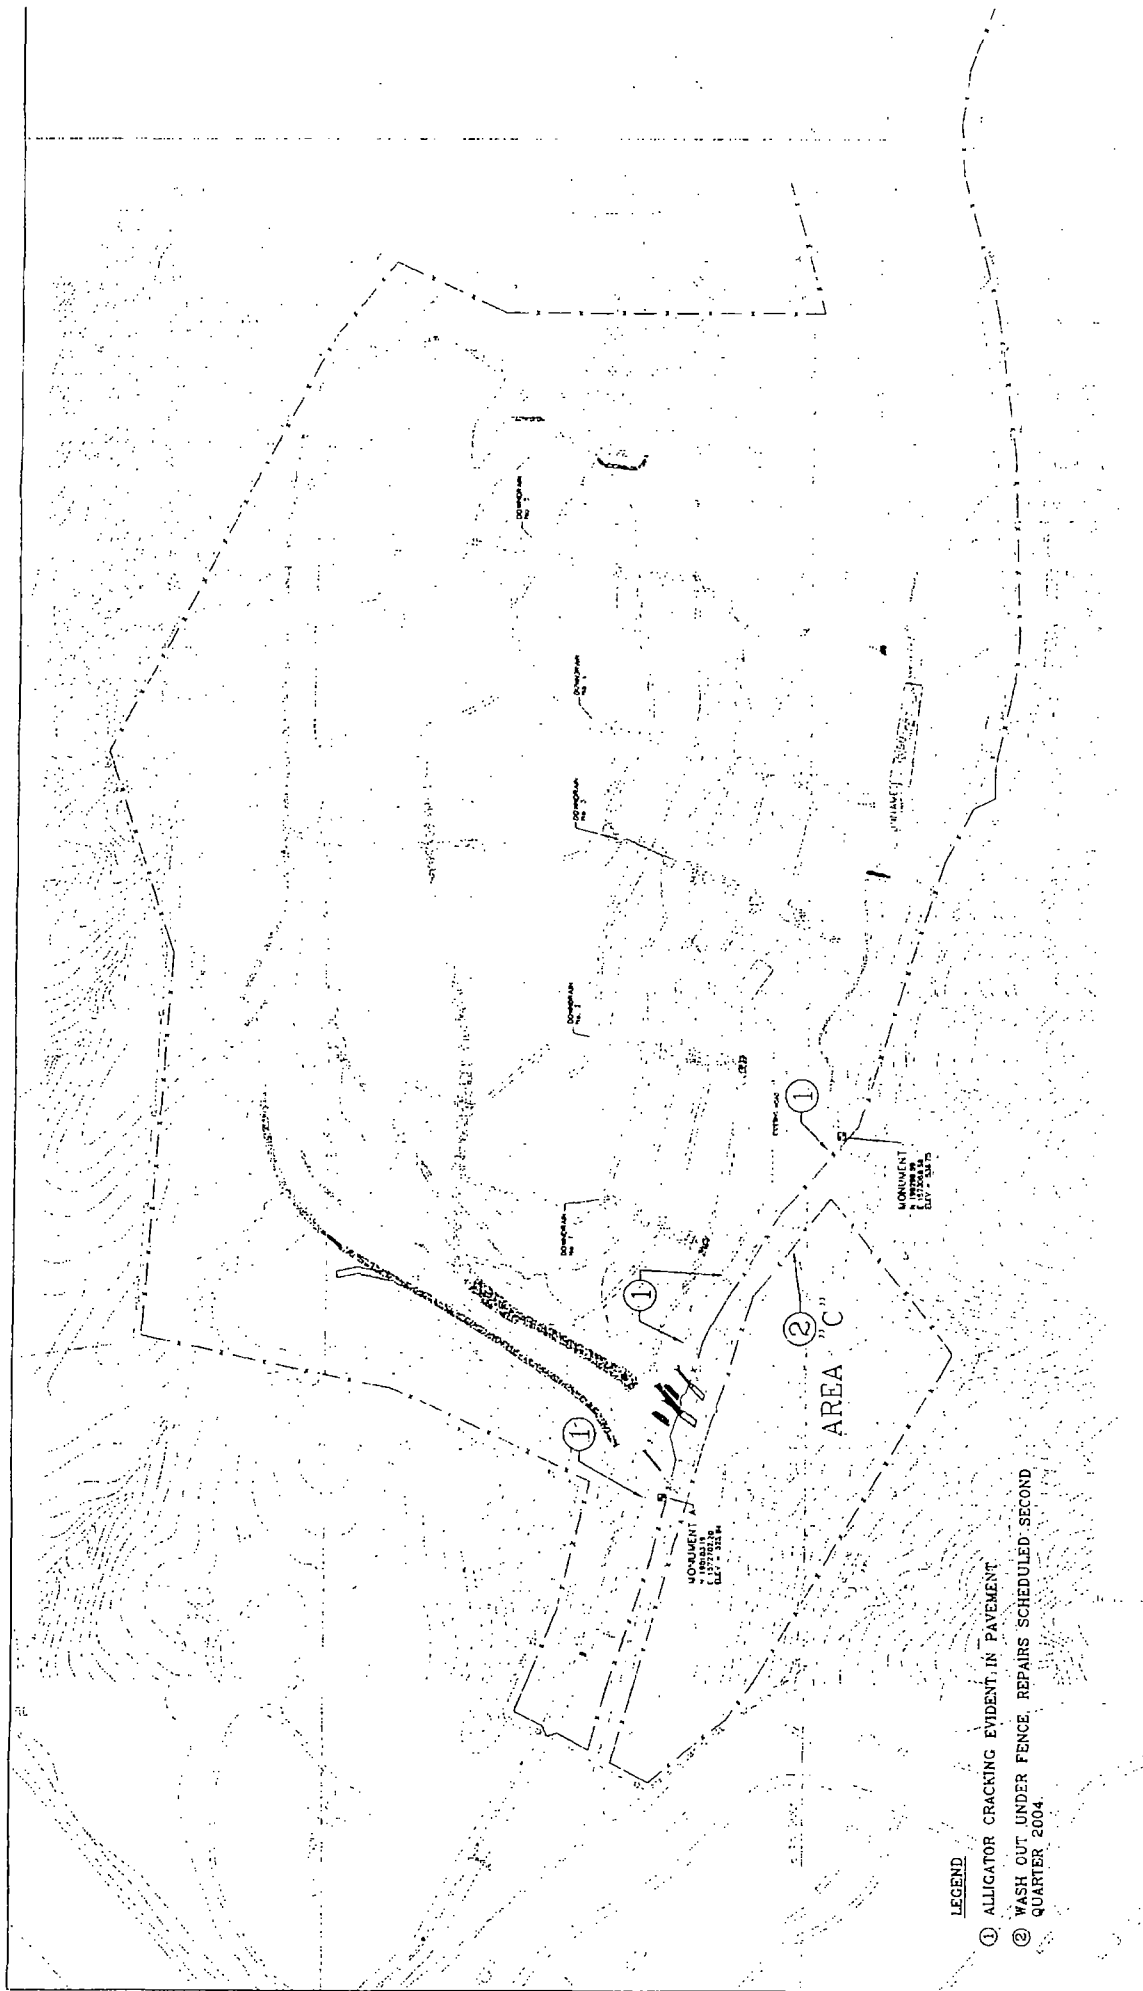
- LEGEND**
- ① ALLIGATOR CRACKING EVIDENT IN PAVEMENT
 - ② WASH OUT UNDER FENCE. REPAIRS SCHEDULED SECOND QUARTER 2004.

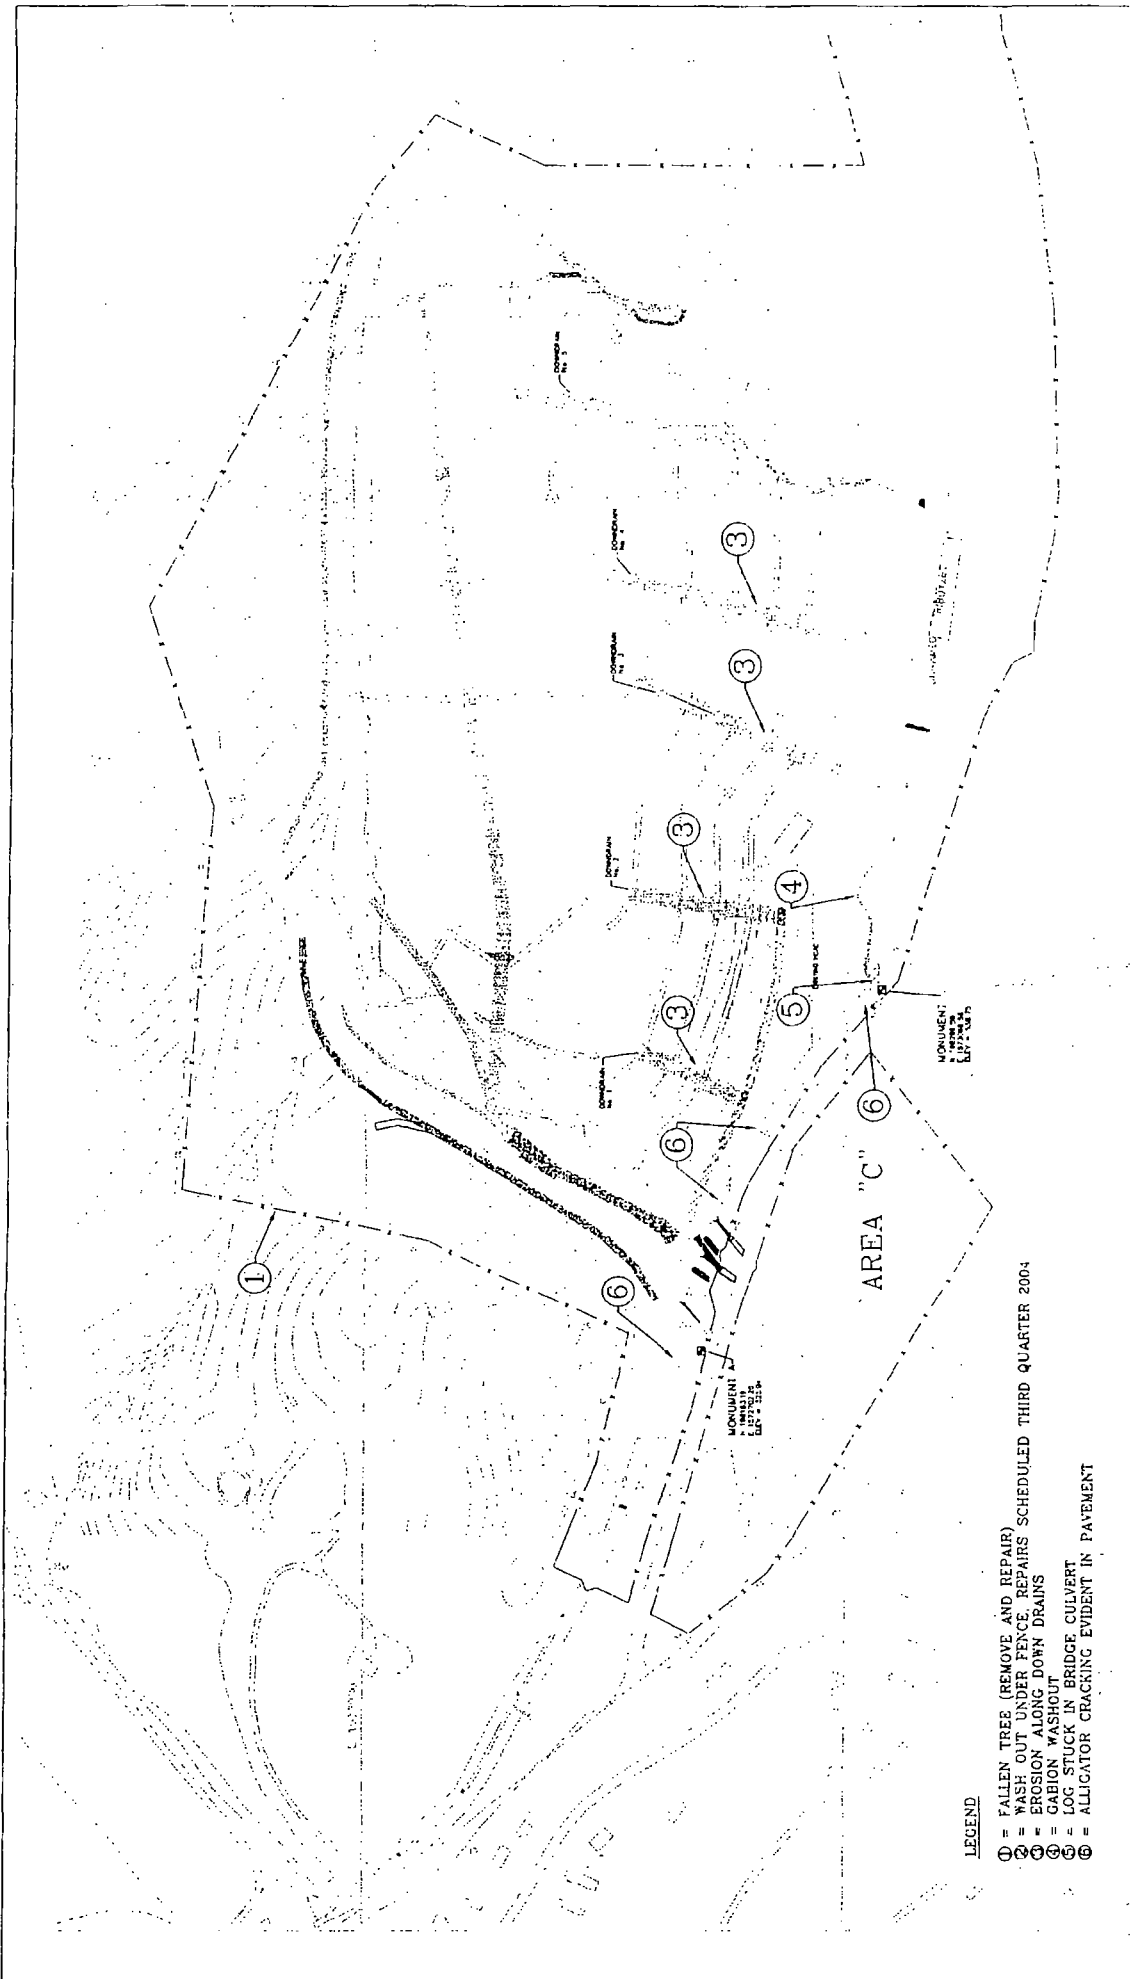
- ① = FALLEN TREE (REMOVE AND REPAIR)
- ② = WASH OUT UNDER FENCE, REPAIRS SCHEDULED THIRD QUARTER 2004
- ③ = EROSION ALONG DOWN DRAINS
- ④ = GABION WASHOUT
- ⑤ = LOG STUCK IN BRIDGE CULVERT
- ⑥ = ALLIGATOR CRACKING EVIDENT IN PAVEMENT

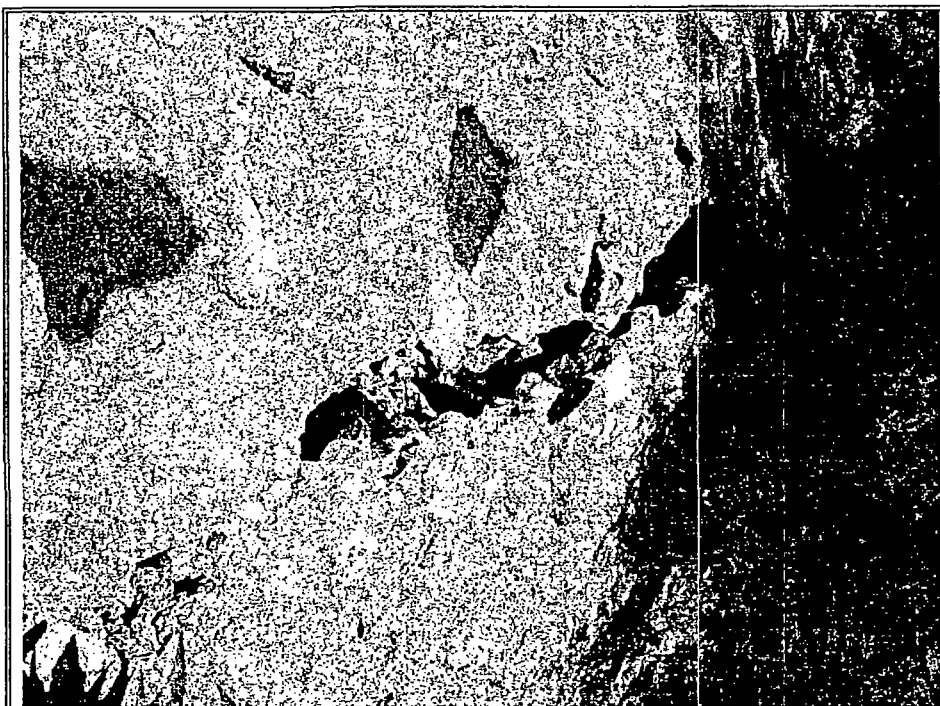
Photograph 3: BROKEN PAVED DITCH

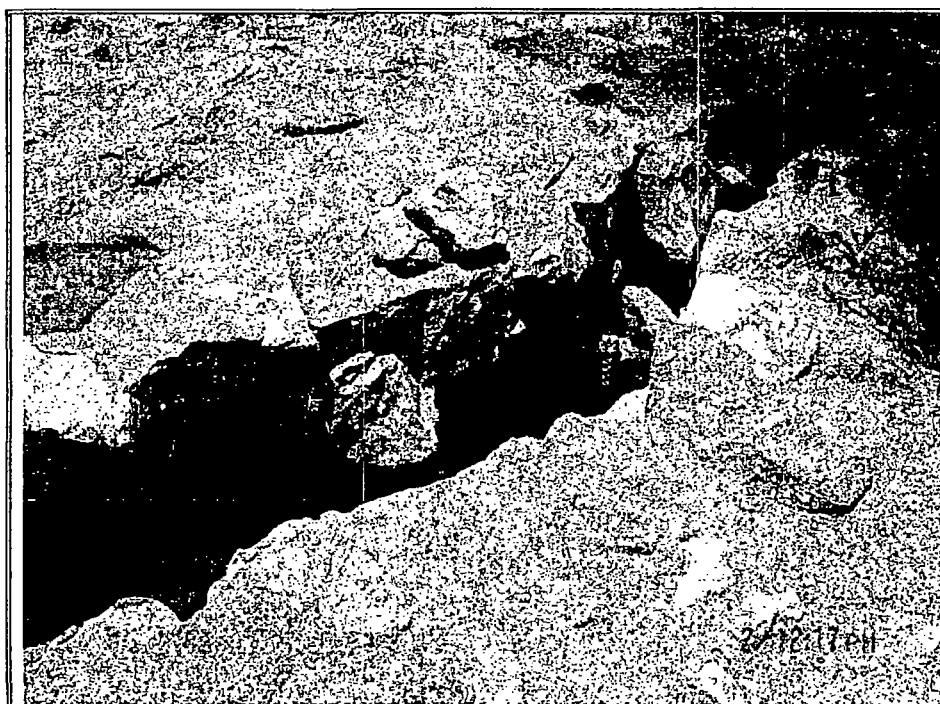
Photograph 4: BROKEN PAVED DITCH

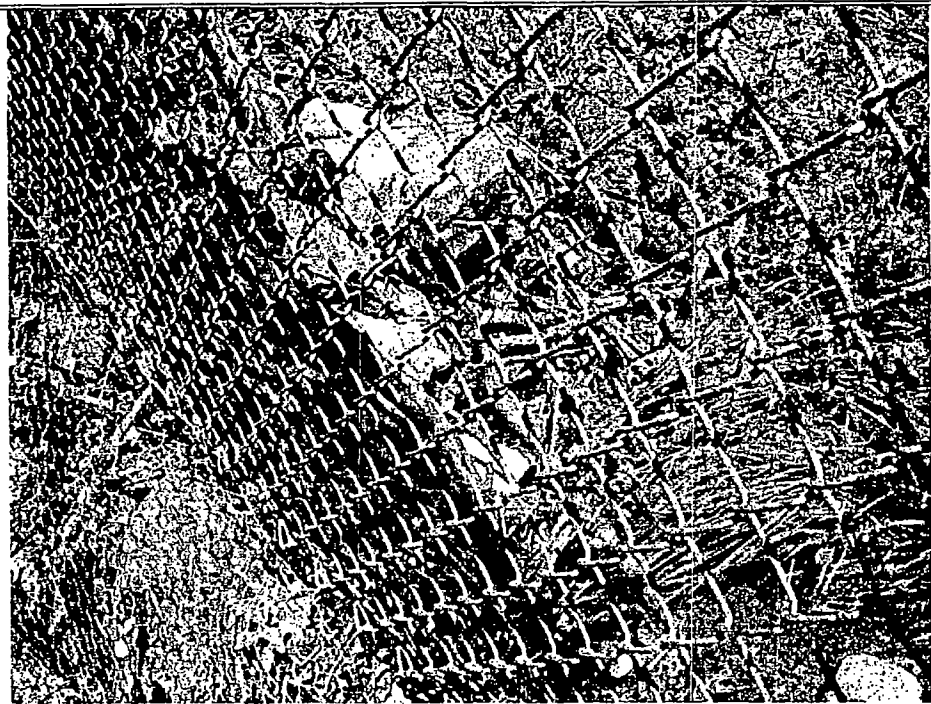
Photograph 5: CLOGGED CULVERT
